4. TEST APPROACH

5. TEST DESCRIPTION

APPENDIX 1 PART A: Test Data Plots

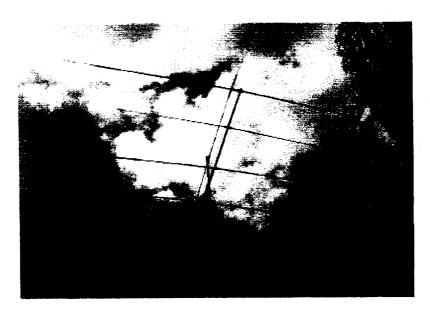
Figure 3-12: Tri-Band Beam and WARC Dipole, and one side of the 40m inverted-V

- ★ <u>Tri-Band Beam³</u>: Hy-GainTM TH7-DXX (Yagi-type) at 49 feet fed with RG-213 coax, 75 feet long. This antenna is rotatable.
- ♦ WARC Dipole⁴: Cushcraft[™] D3W rotatable dipole at 54 feet fed with RG-213 coax, 80 feet long. The antenna is a single element dipole which

employs traps as uned elements for each of the bands. It is mounted above the Tri-Band Beam on the tower mast and is orthogonal to the orientation of the Tri-Band Beam.
